# RL10A-3-3 ROCKET ENGINE OXIDIZER PUMP DEVELOPMENT PROGRAM

Prepared Under NASA  
Contract NAS8-15494  
August 1965 to June 1966

**Pratt & Whitney Aircraft**  
FLORIDA RESEARCH AND DEVELOPMENT CENTER

30 DEC 1966

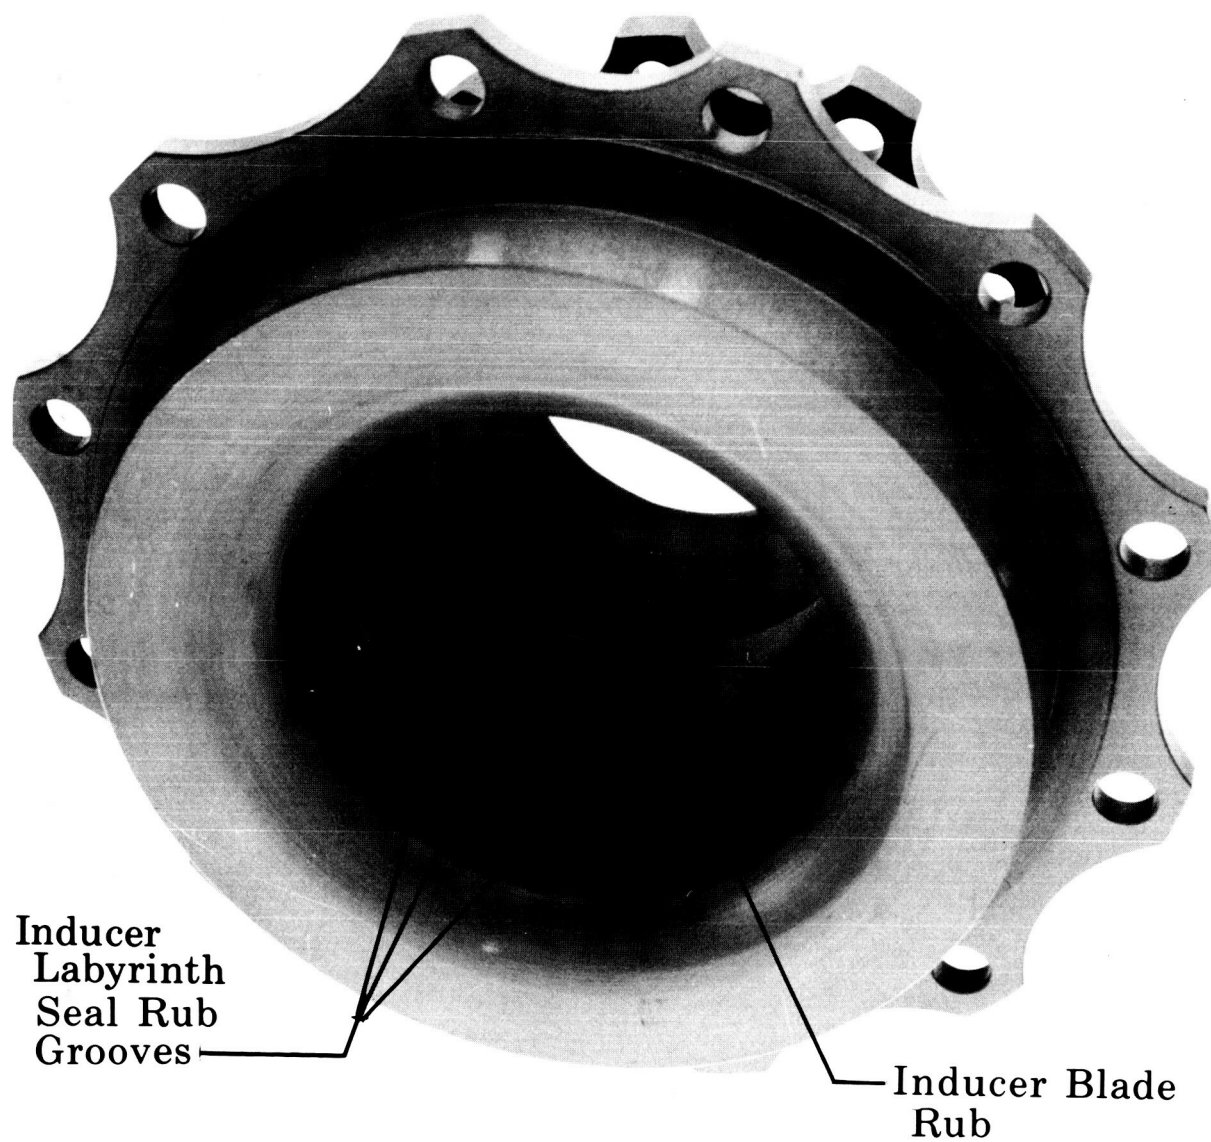
The decision to allow metal-to-metal rubbing in the inducer seal areas was supported by favorable results from rub tests in liquid oxygen conducted on a specially constructed test rig and oxidizer pump rig tests specifically directed to determine inducer-to-housing rubbing compatibility. The rub test program on the special rub rig is described in attached Appendix A. The RL10A-3-3 development engines have accumulated more than 53 hours of test time, and 140 hours of oxidizer pump rig testing with this configuration have been completed with no detrimental or hazardous pump operation from the inducer-to-housing rub. Inducer-to-housing rubbing was experienced during the major portion of this testing. A typical inducer housing showing the inducer seal and blade rubs is shown in figure I-2.

Figure I-2. RL10A-3-3 Oxidizer Pump Inducer  
Housing

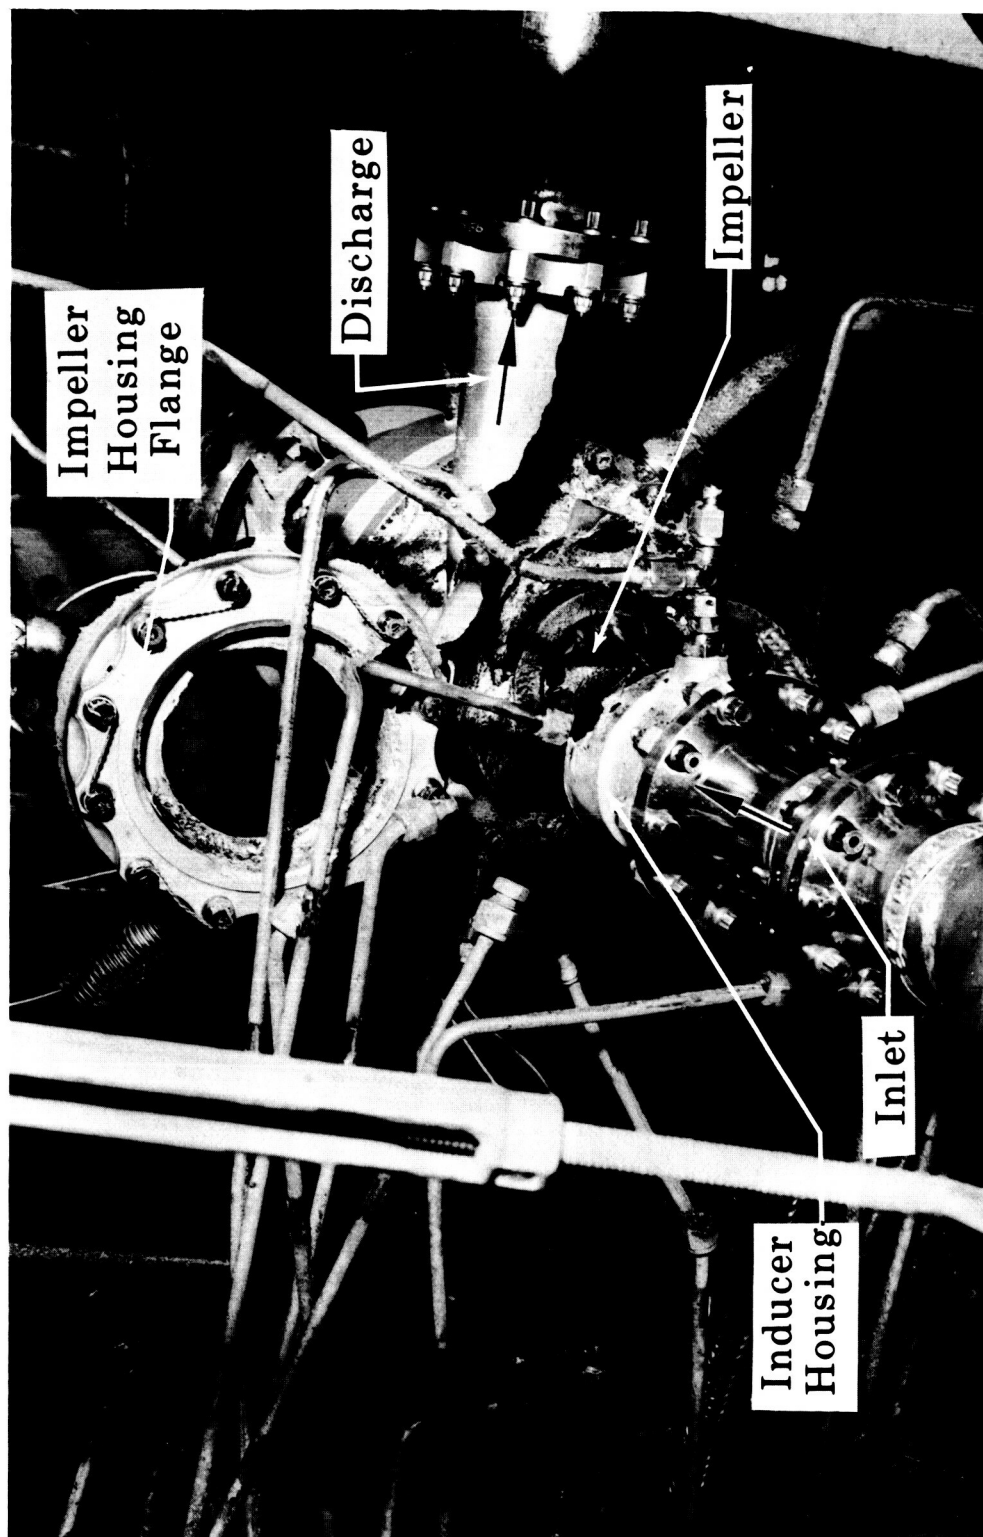
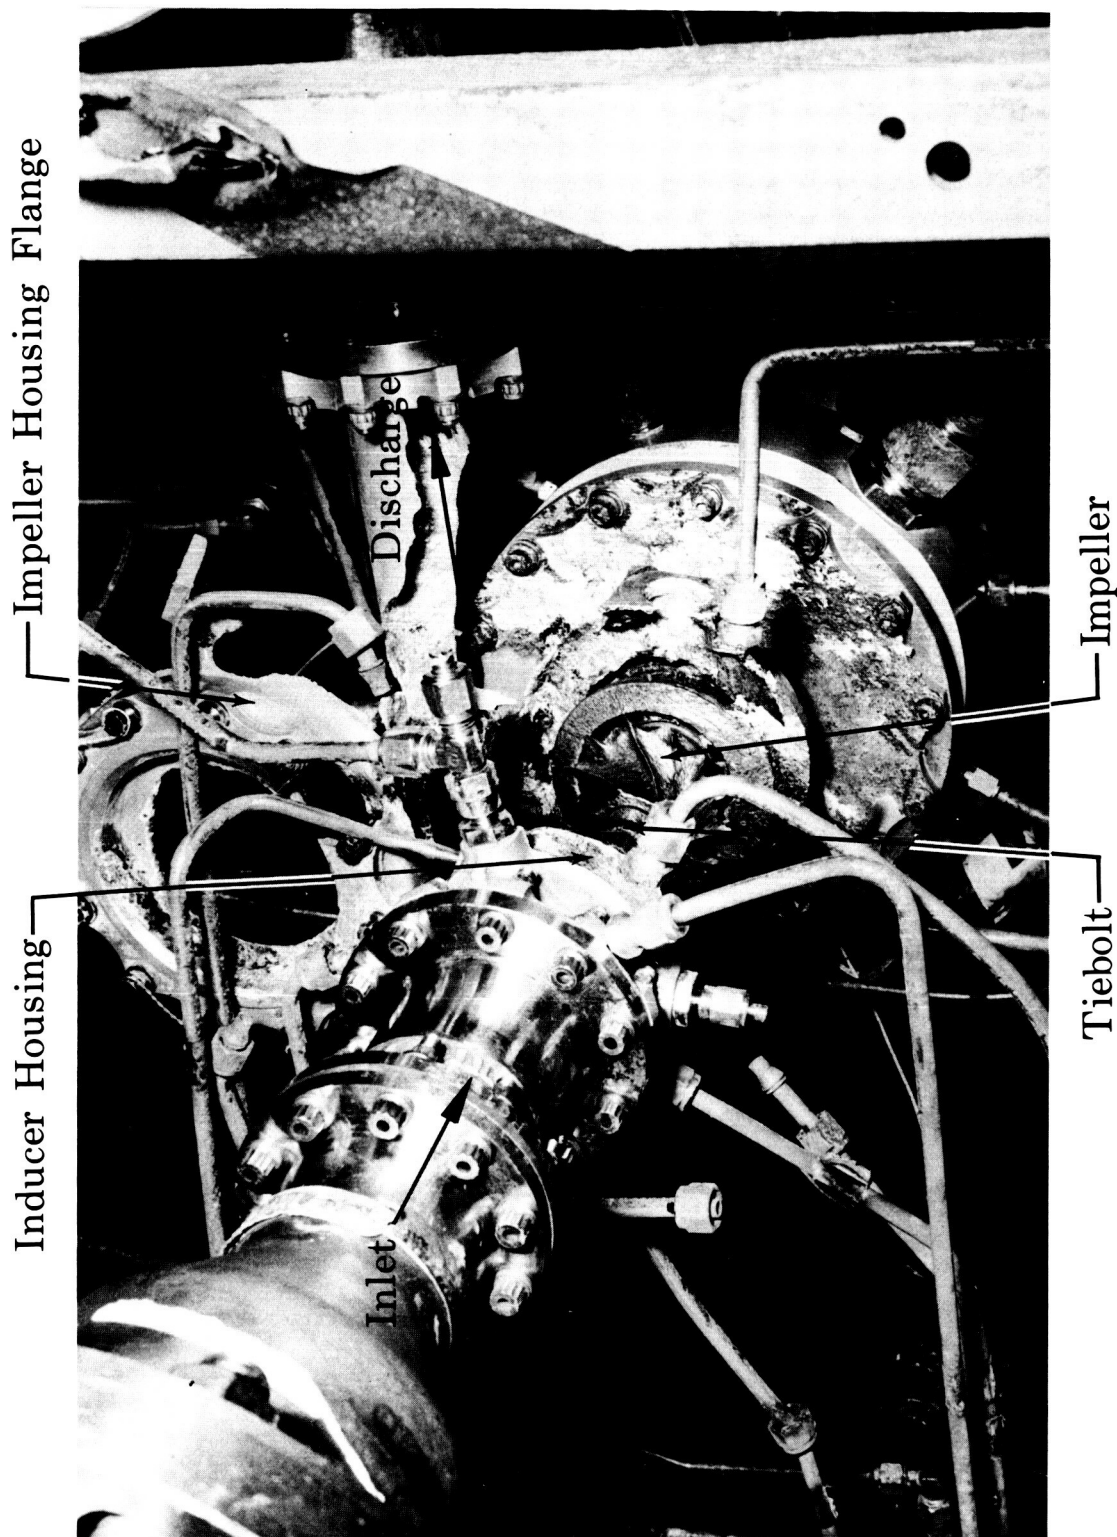
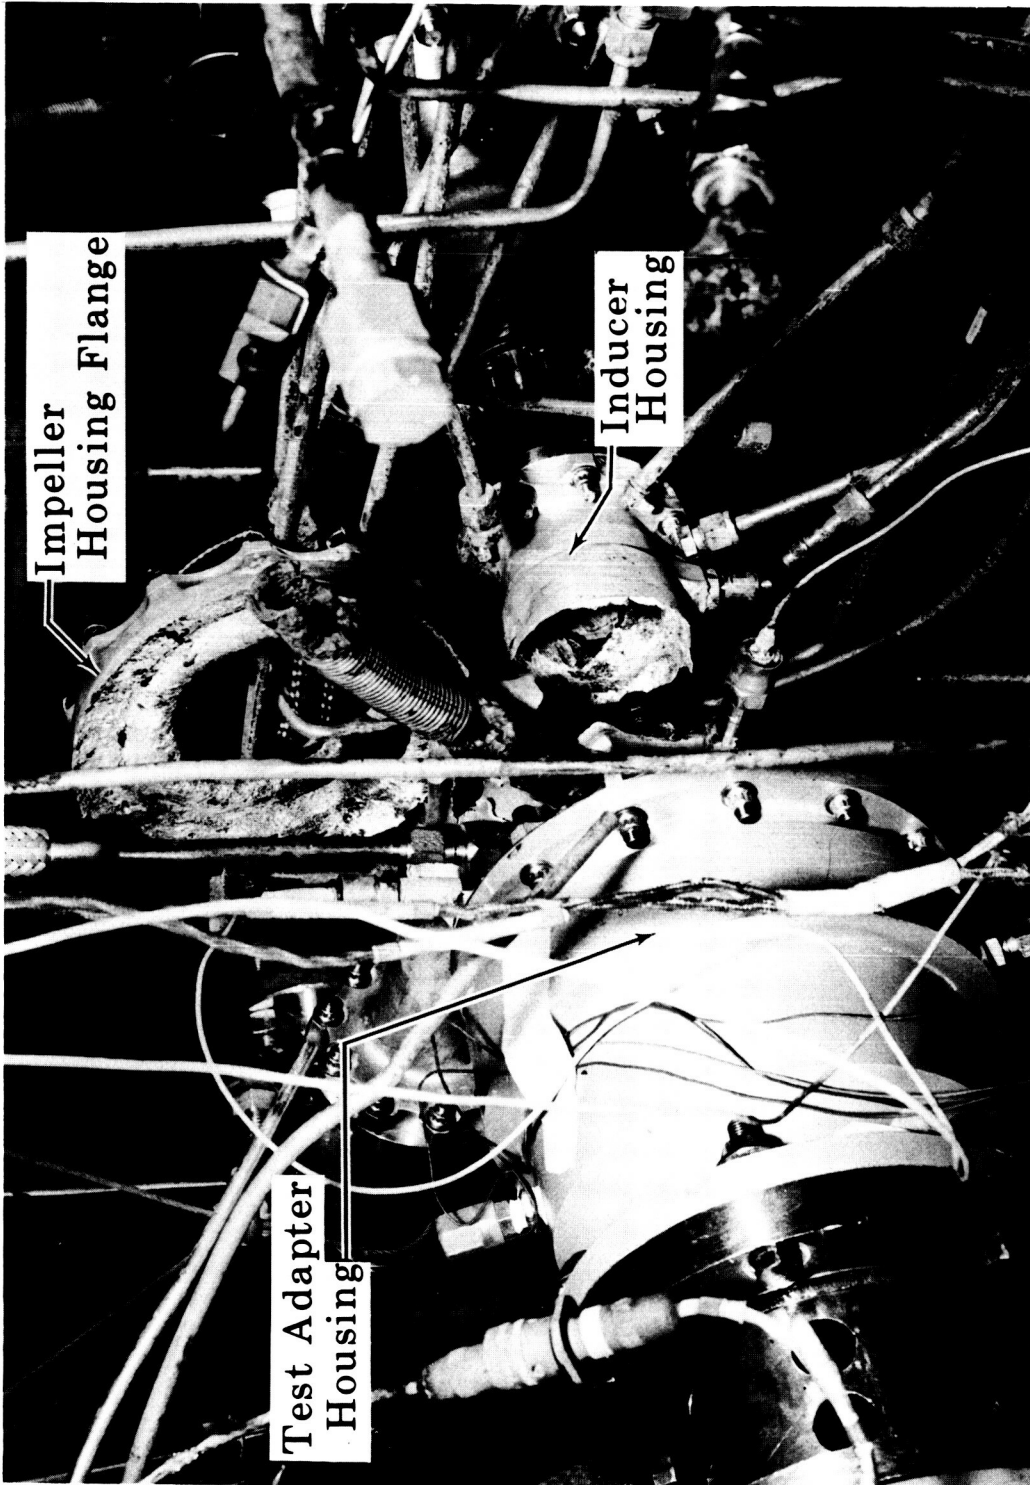
Figure II-11. RL10A-3-3 Oxidizer Pump Failure (Rig B71C003-11)

Figure II-12. RL10A-3-3 Oxidizer Pump Failure (Rig B71C003-11)

Figure II-13. RL10A-3-3 Oxidizer Pump Failure (Rig B71C003-11)

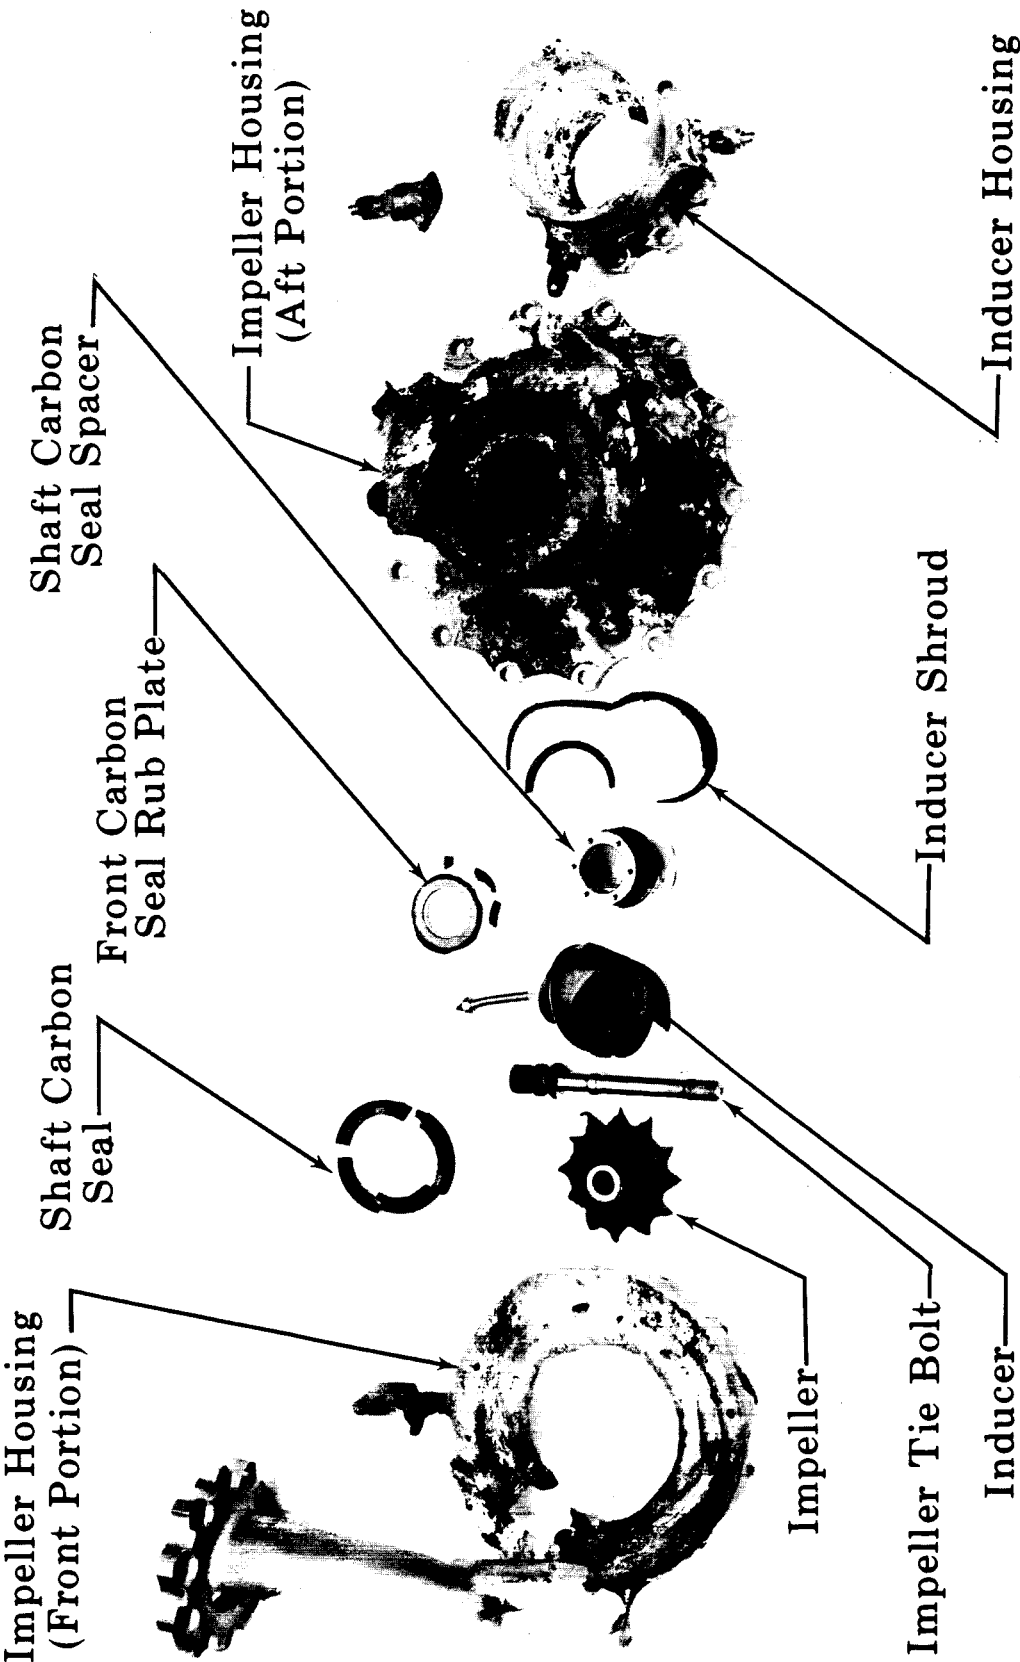
Figure II-14. RL10A-3-3 Oxidizer Pump Parts After Failure (Rig B71C003-11)

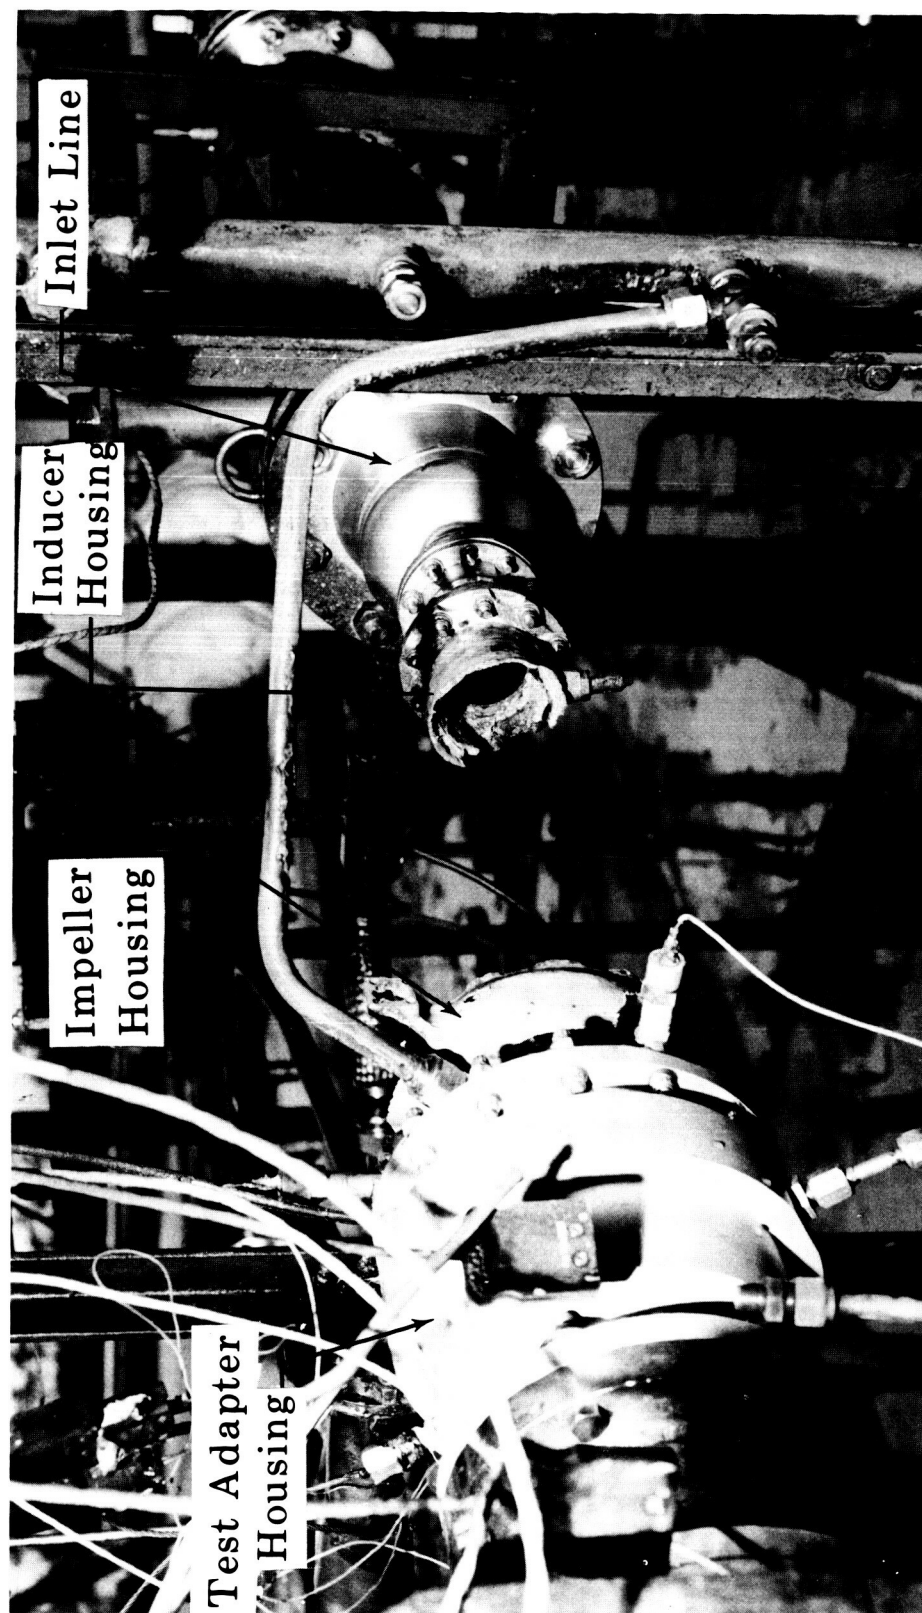
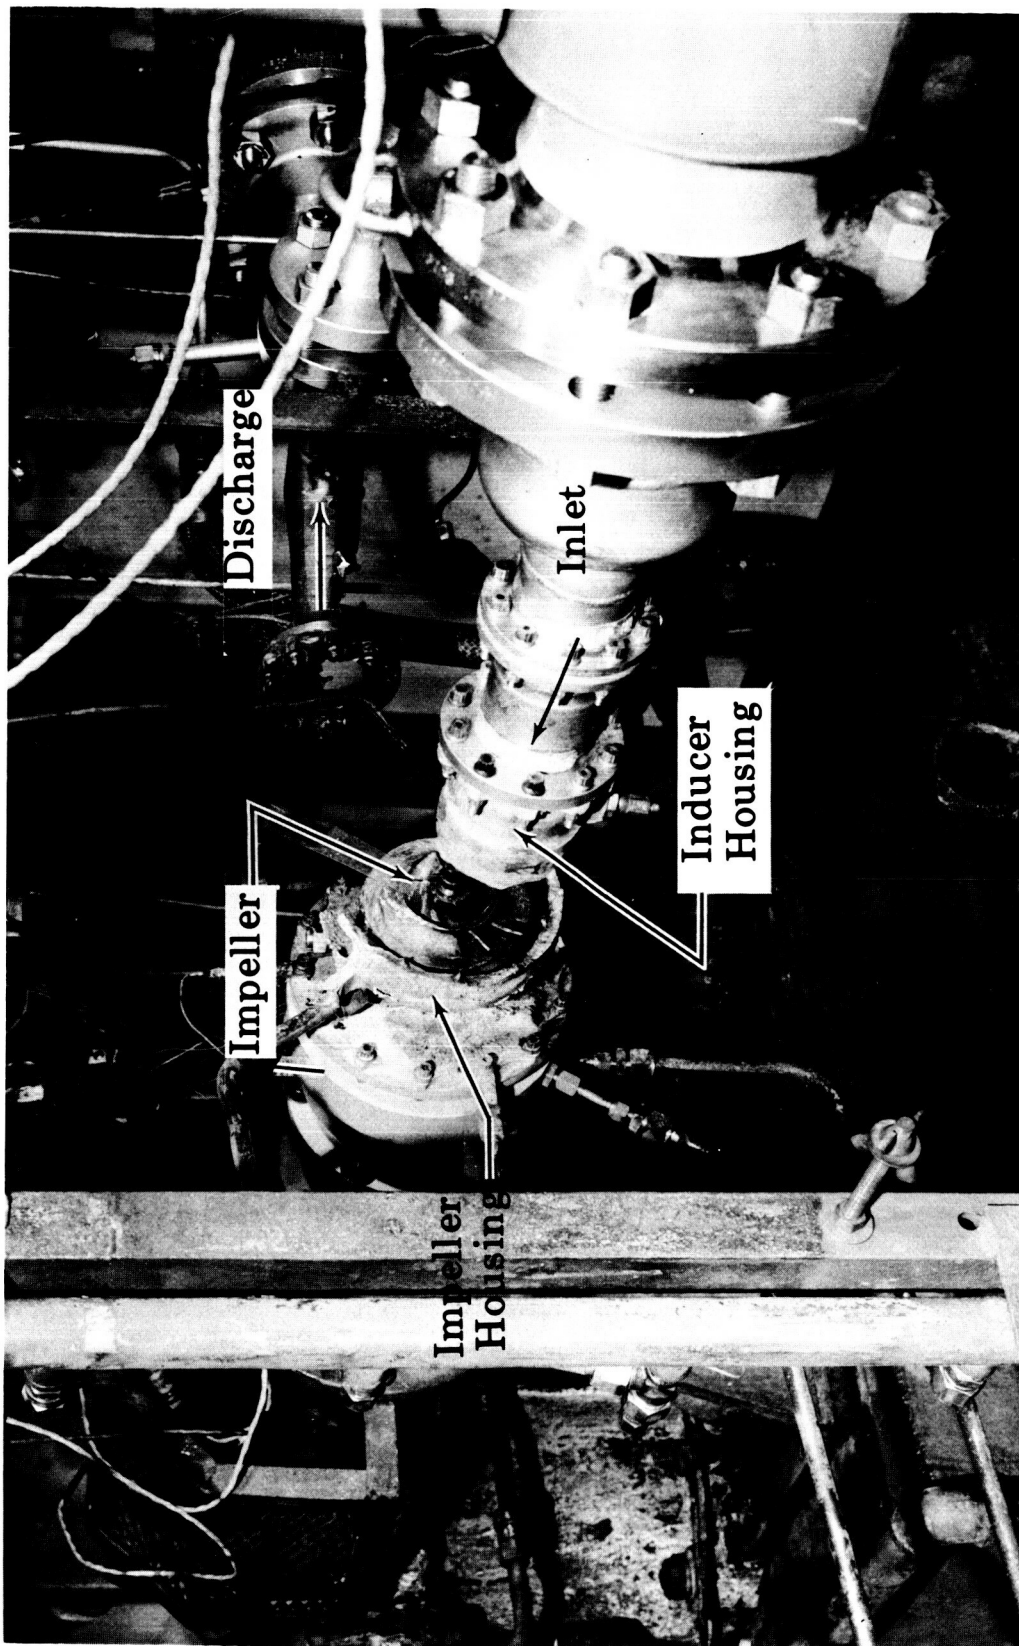
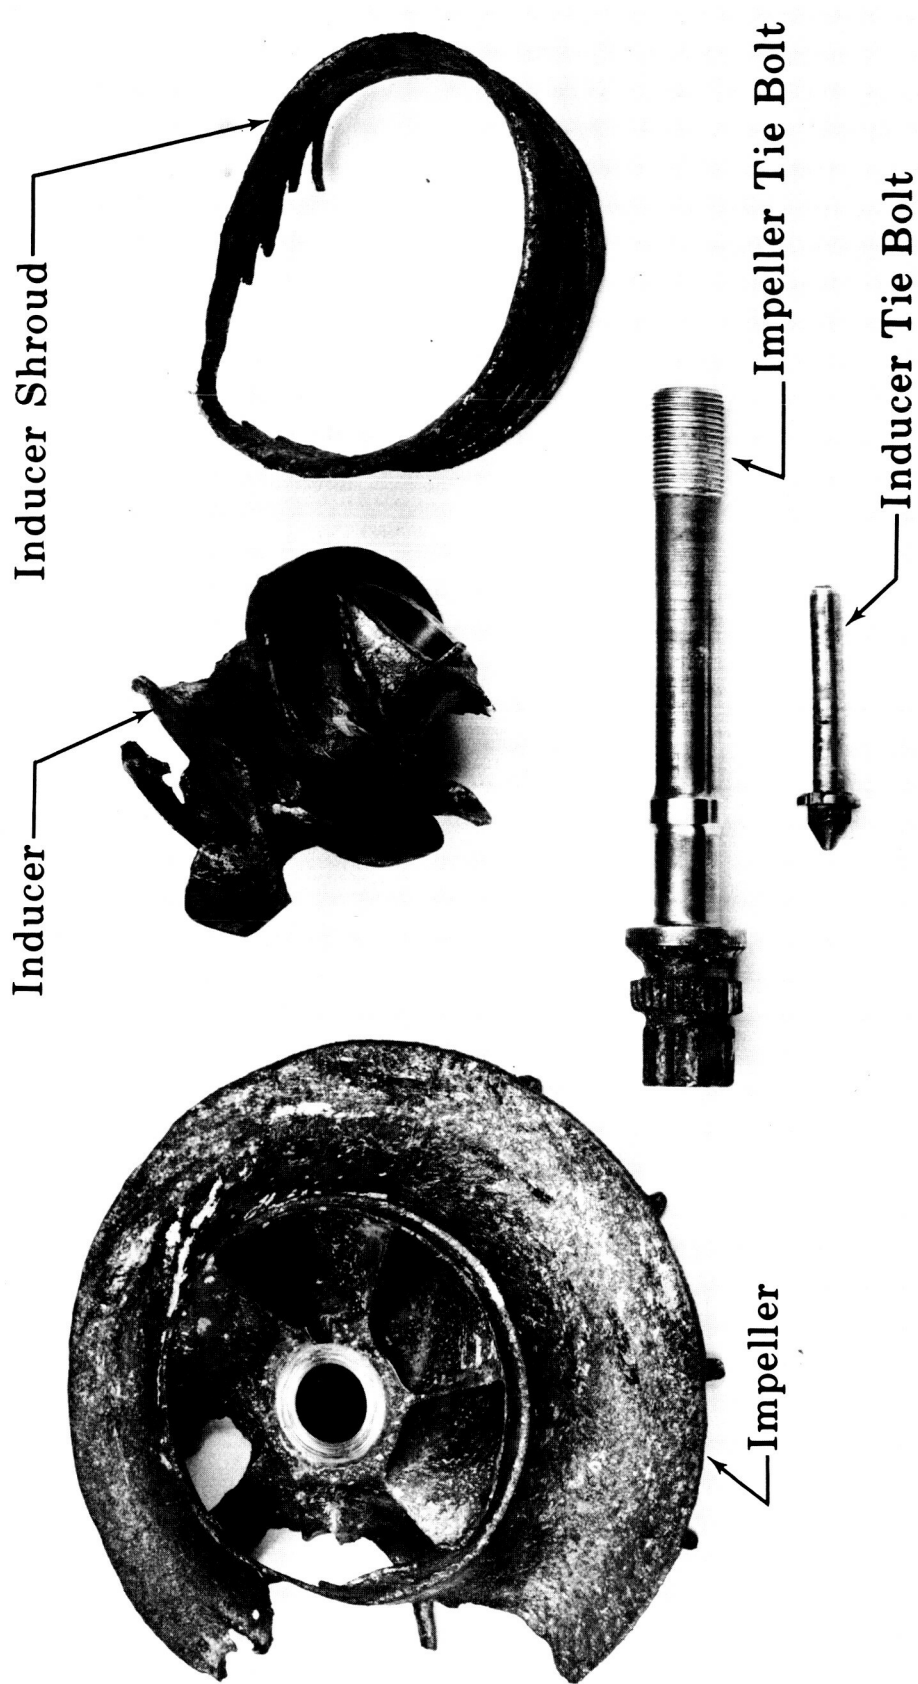
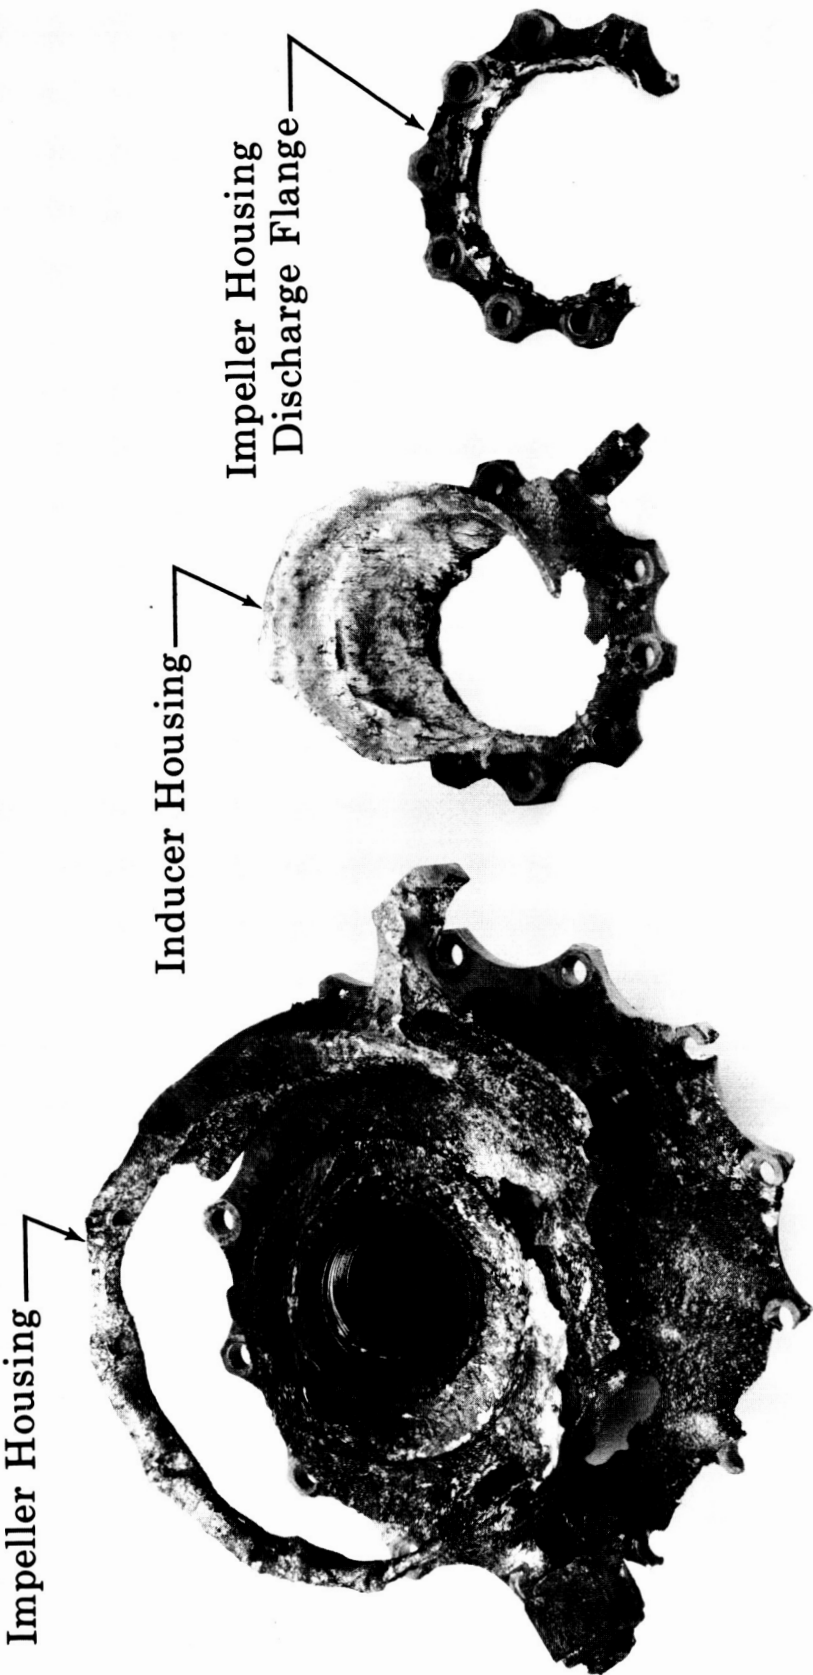
parts list rub plate for this test. This second failure occurred after the third NPSP data run had been completed. The pump, recovering from a 35% cavitation point, was operating at a speed of 12,000 rpm and a flow of 185 gpm. Again no pump abnormalities were observed before this failure. General views of the failed pump are shown in figures II-16, II-17, II-18, and II-19.

Figure II-16. RL10A-3-3 Oxidizer Pump Failure (Rig B71C003-12)

Figure II-17. RL10A-3-3 Oxidizer Pump Failure (Rig B71C003-12)

Figure II-18. RL10A-3-3 Oxidizer Pump Parts After Failure (Rig B71C003-12)

Figure II-19. RL10A-3-3 Oxidizer Pump Parts After Failure (Rig B71C003-12)

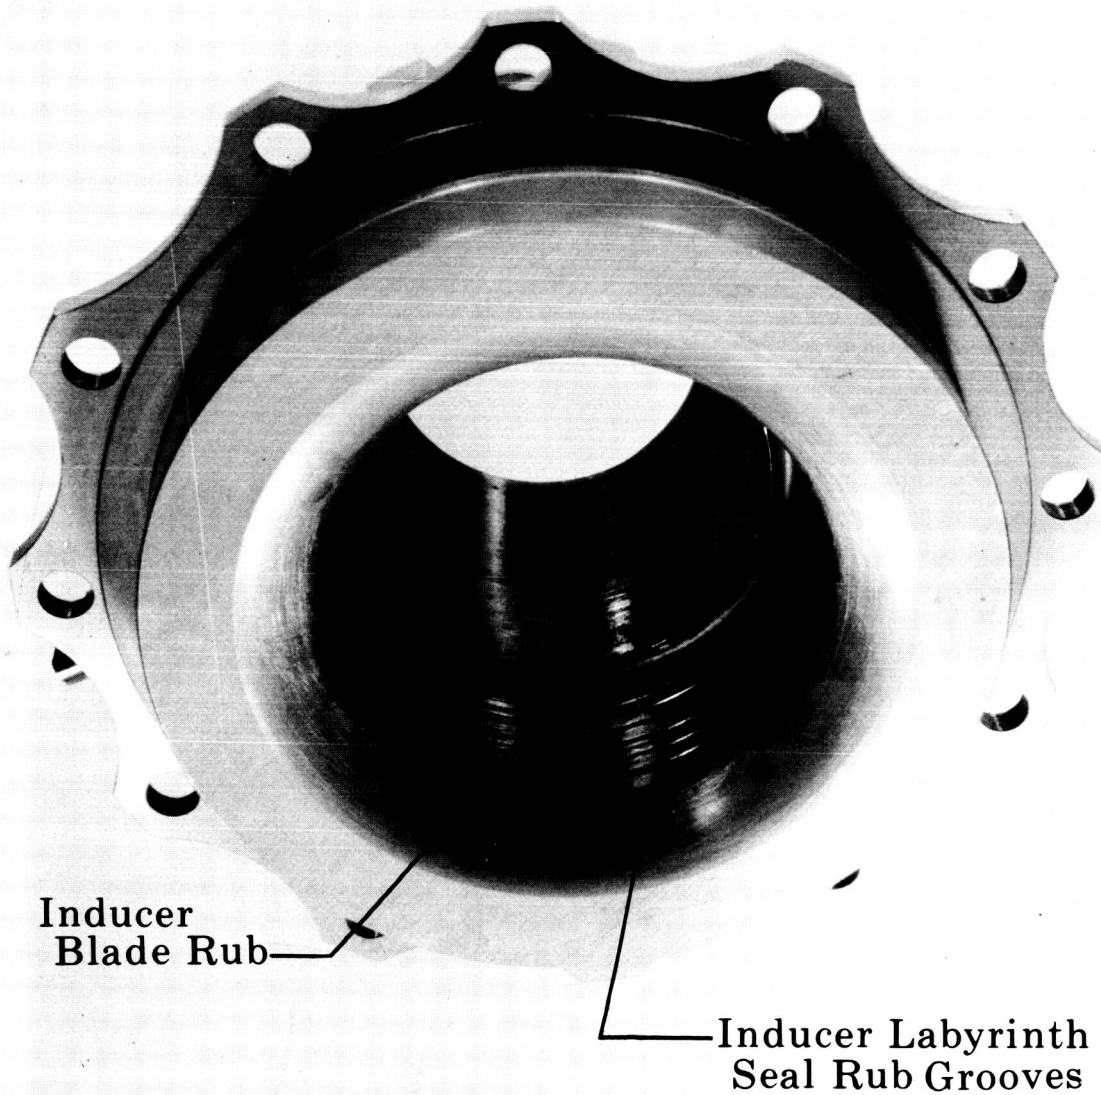
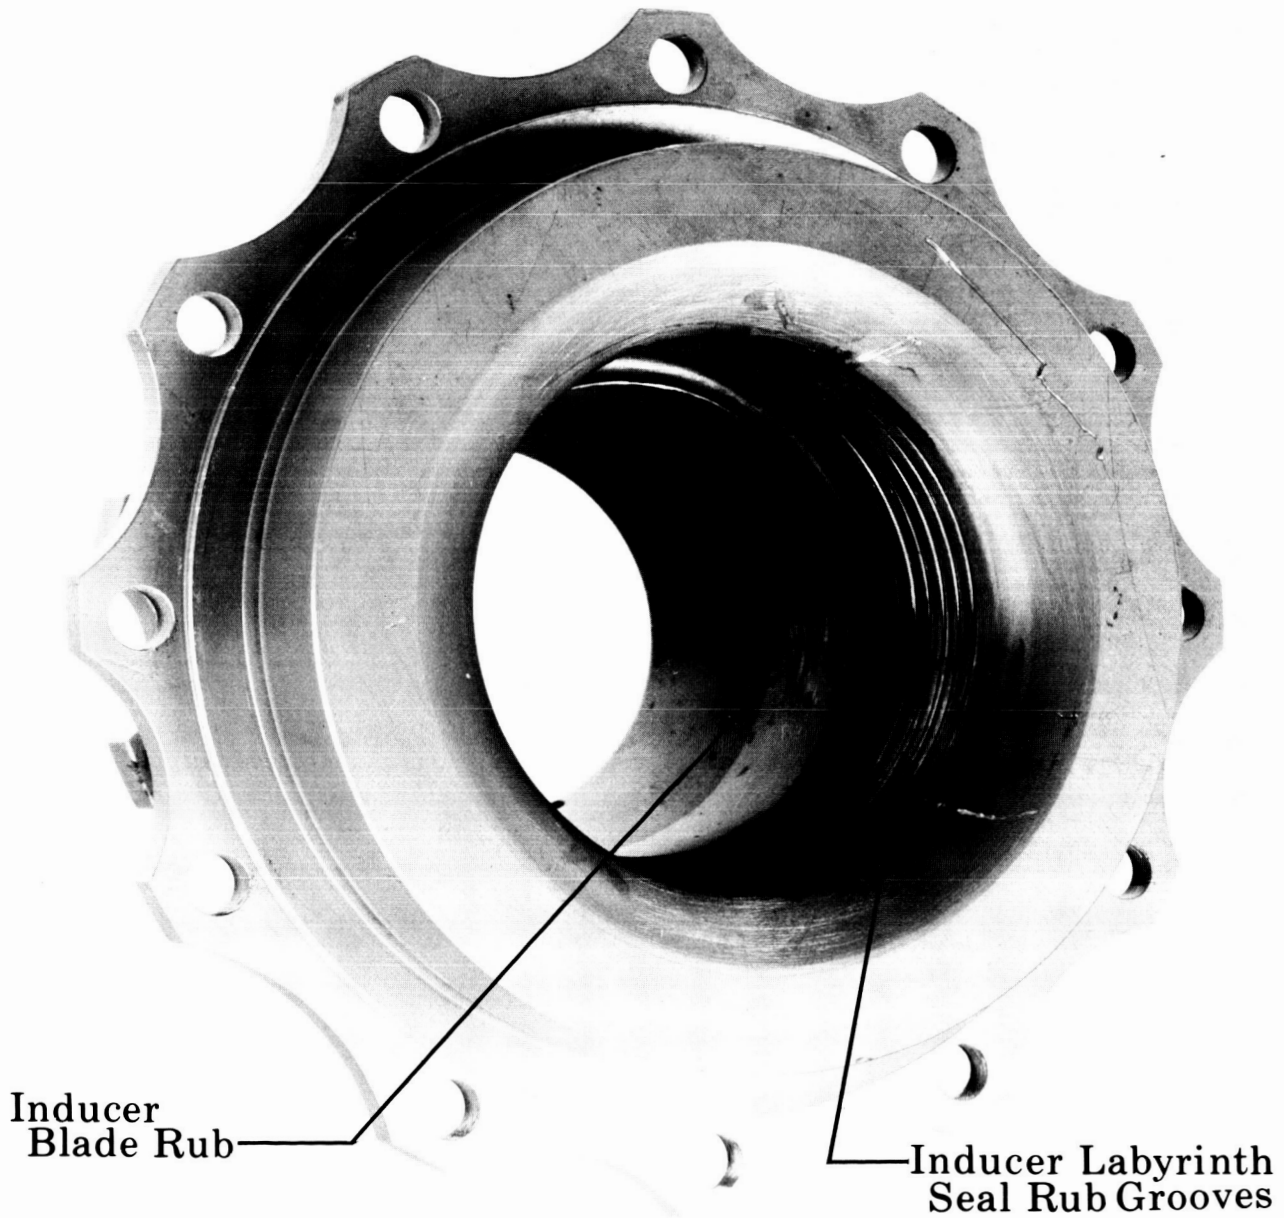
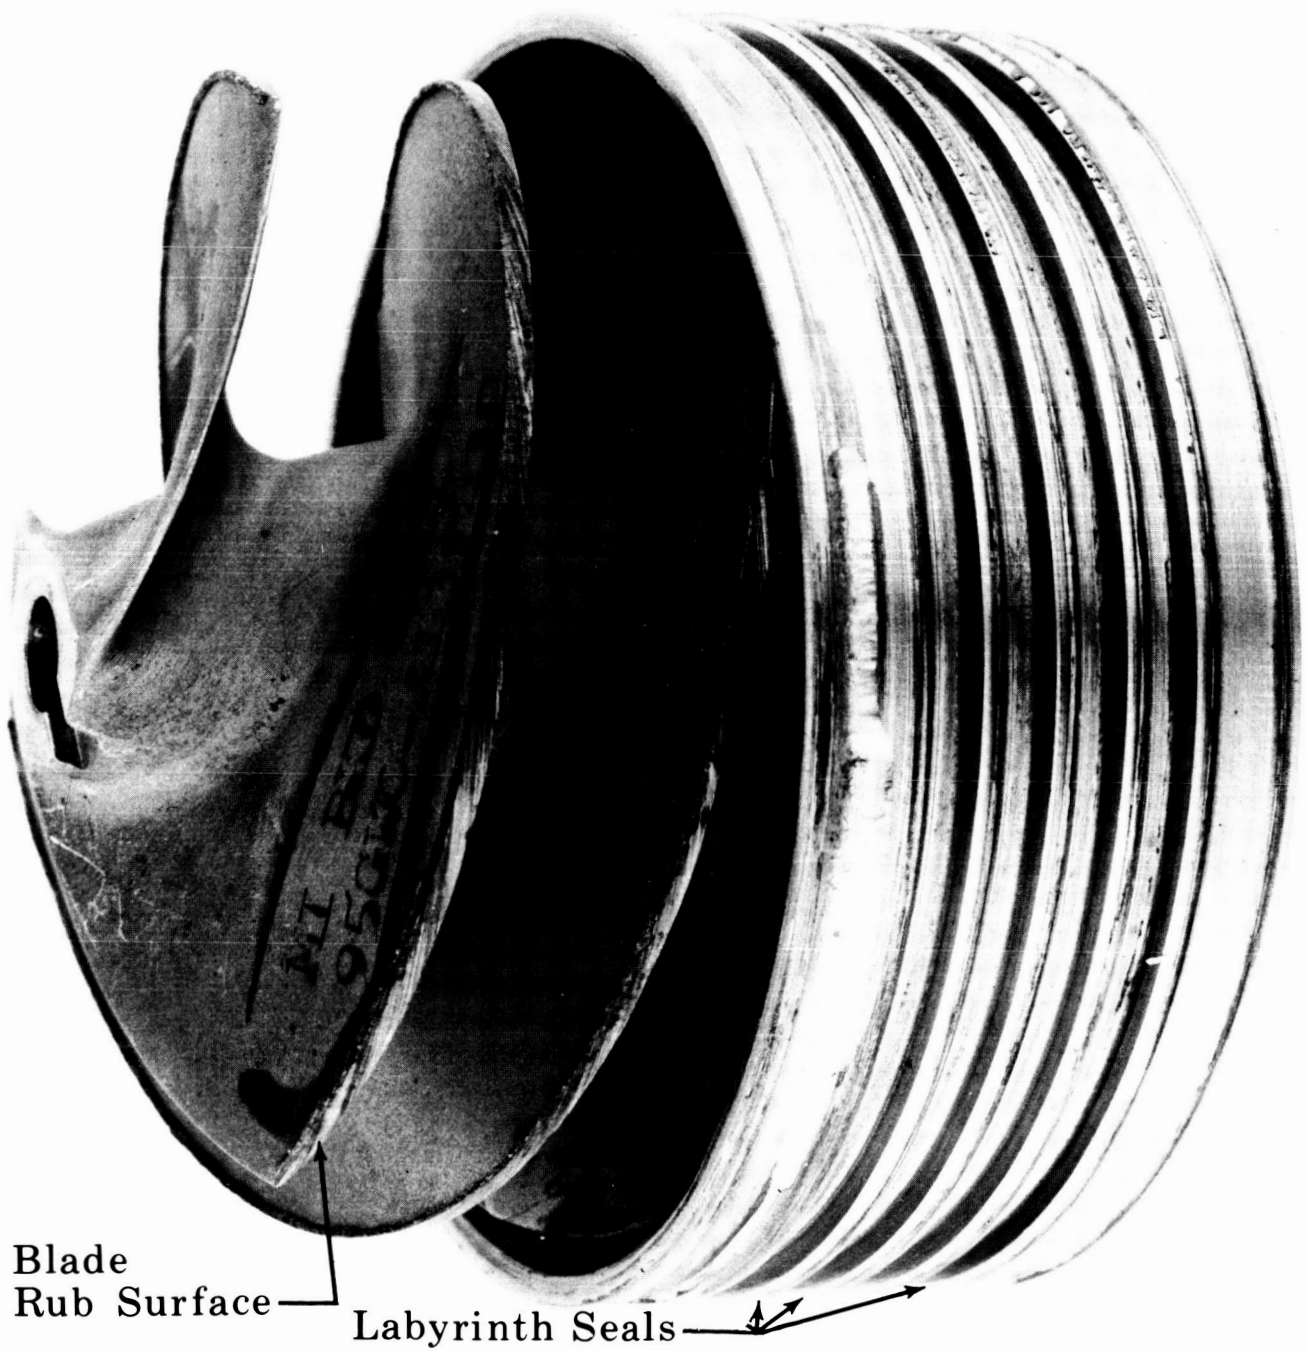
2. Inducer labyrinth seal and forward blade rubs resulted from the above tests, which included deep cavitation runs to 40%. There were no impeller rubs. Contact between the inducer and inducer housing was similar to that observed during previous engine and rig pump testing as seen in figures II-20, through II-22.

Figure II-20. RL10A-3-3 Oxidizer Pump Inducer  
Housing (Rig B71C003-15)

Figure II-21. RL10A-3-3 Oxidizer Pump Inducer  
Housing (Rig B71C003-16)

Figure II-22. RL10A-3-3 Oxidizer Pump Inducer  
Housing (Rig B71C003-16)

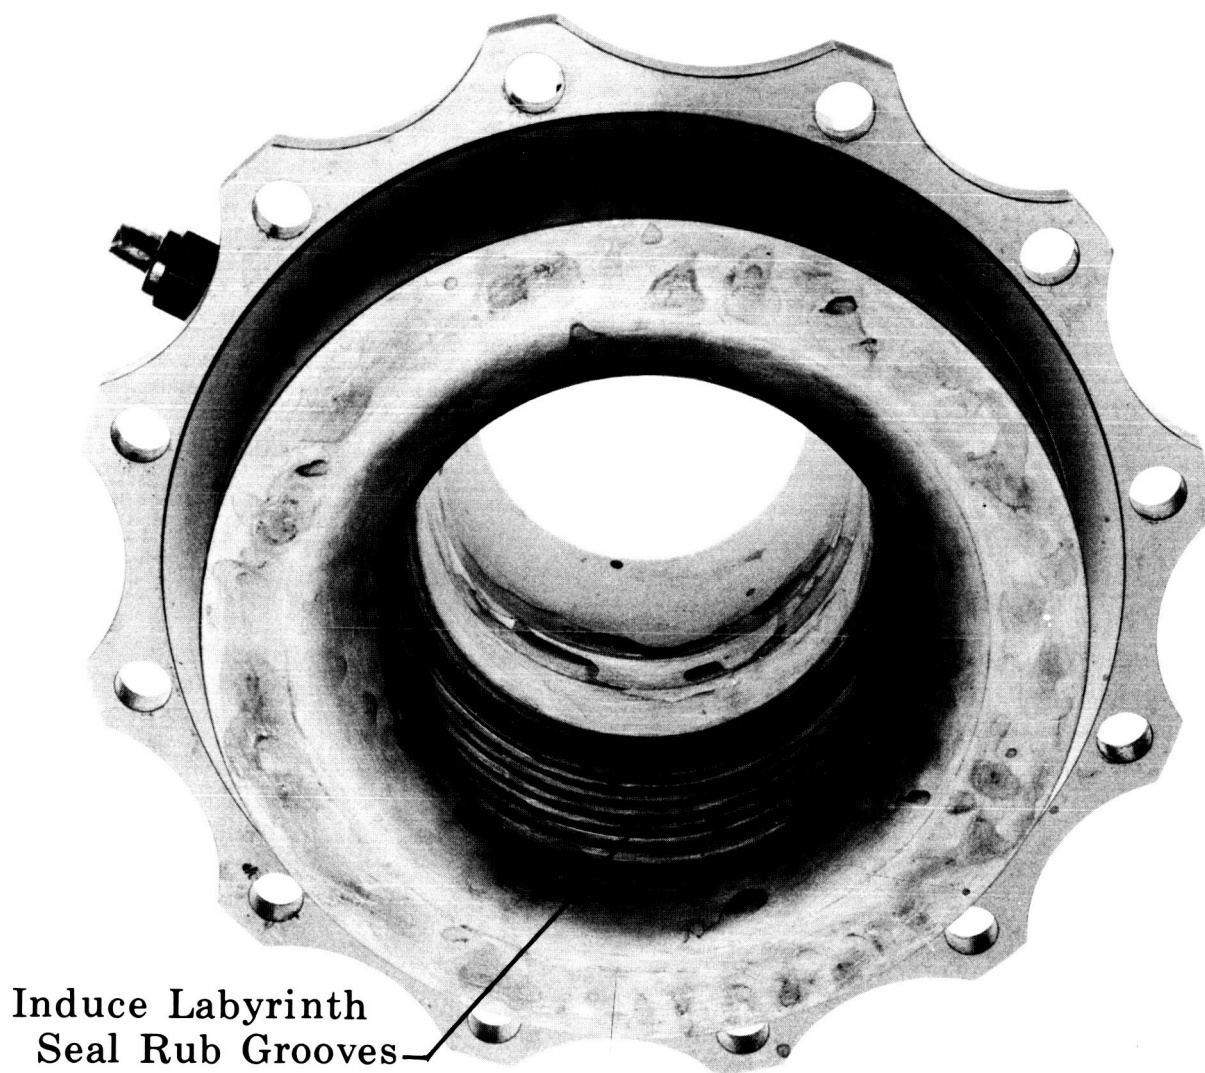
Pump tests were also conducted on special rub rig, B71C005, shown on figure II-5 with heavy inducer labyrinth seal-to-housing rubs. A wide blade clearance of 0.140 in. was set to prevent rubbing in the blade area. In these runs the inducer was forced against the inducer housing with a 1000-lb load applied radially at the thrust bearing support. Again no fire was produced. Labyrinth seal grooves to the depth of 0.014 in. were worn into the housing as can be seen in figure II-23.

Figure II-23. RL10A-3-3 Oxidizer Pump Inducer Housing (Rig B71C005-3A)
